Structural Tests of Mechanical Connections For Concrete Panels

L. E. Cattaneo and F. Y. Yokel

Final Report

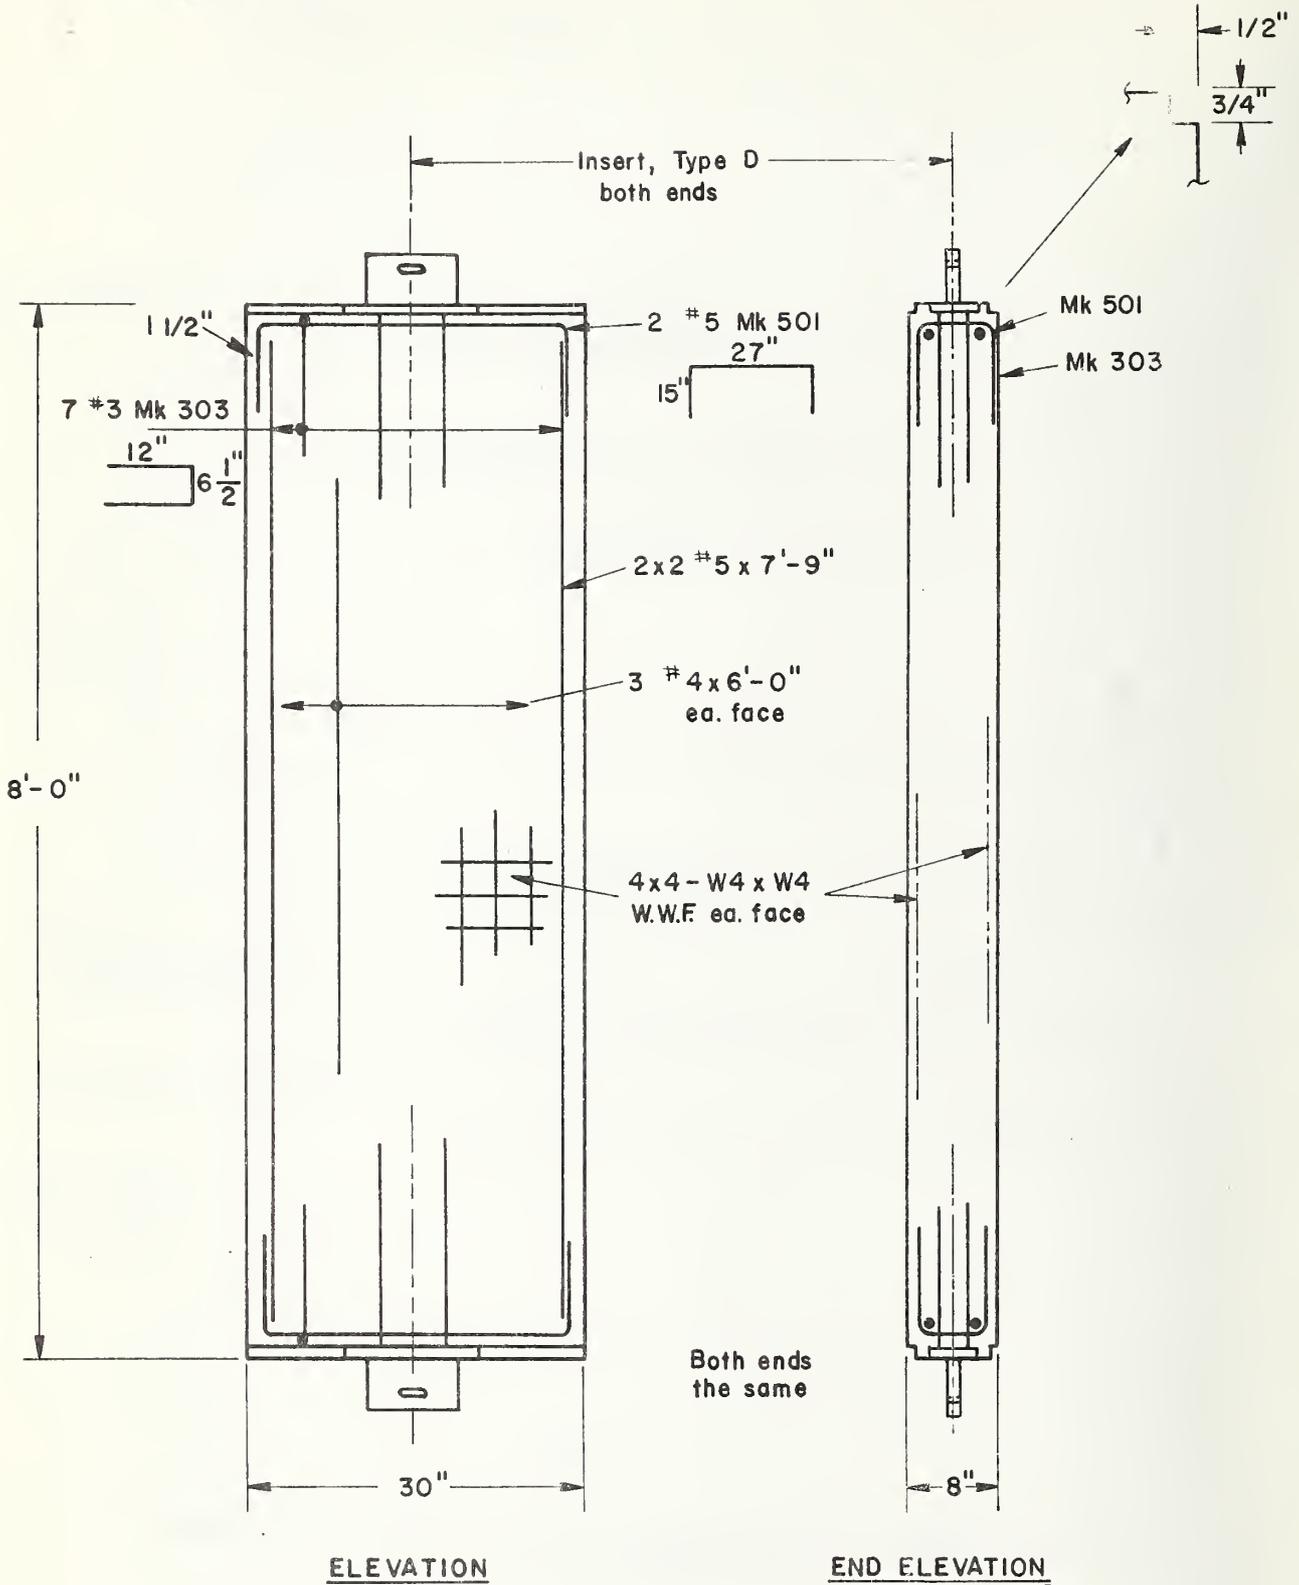
Concrete: 4000 psi @ 28 days
 Re. Steel: A-615 Grade 60

Figure 2.2.3 Original design of double-top-ended wall test specimens (Type D).

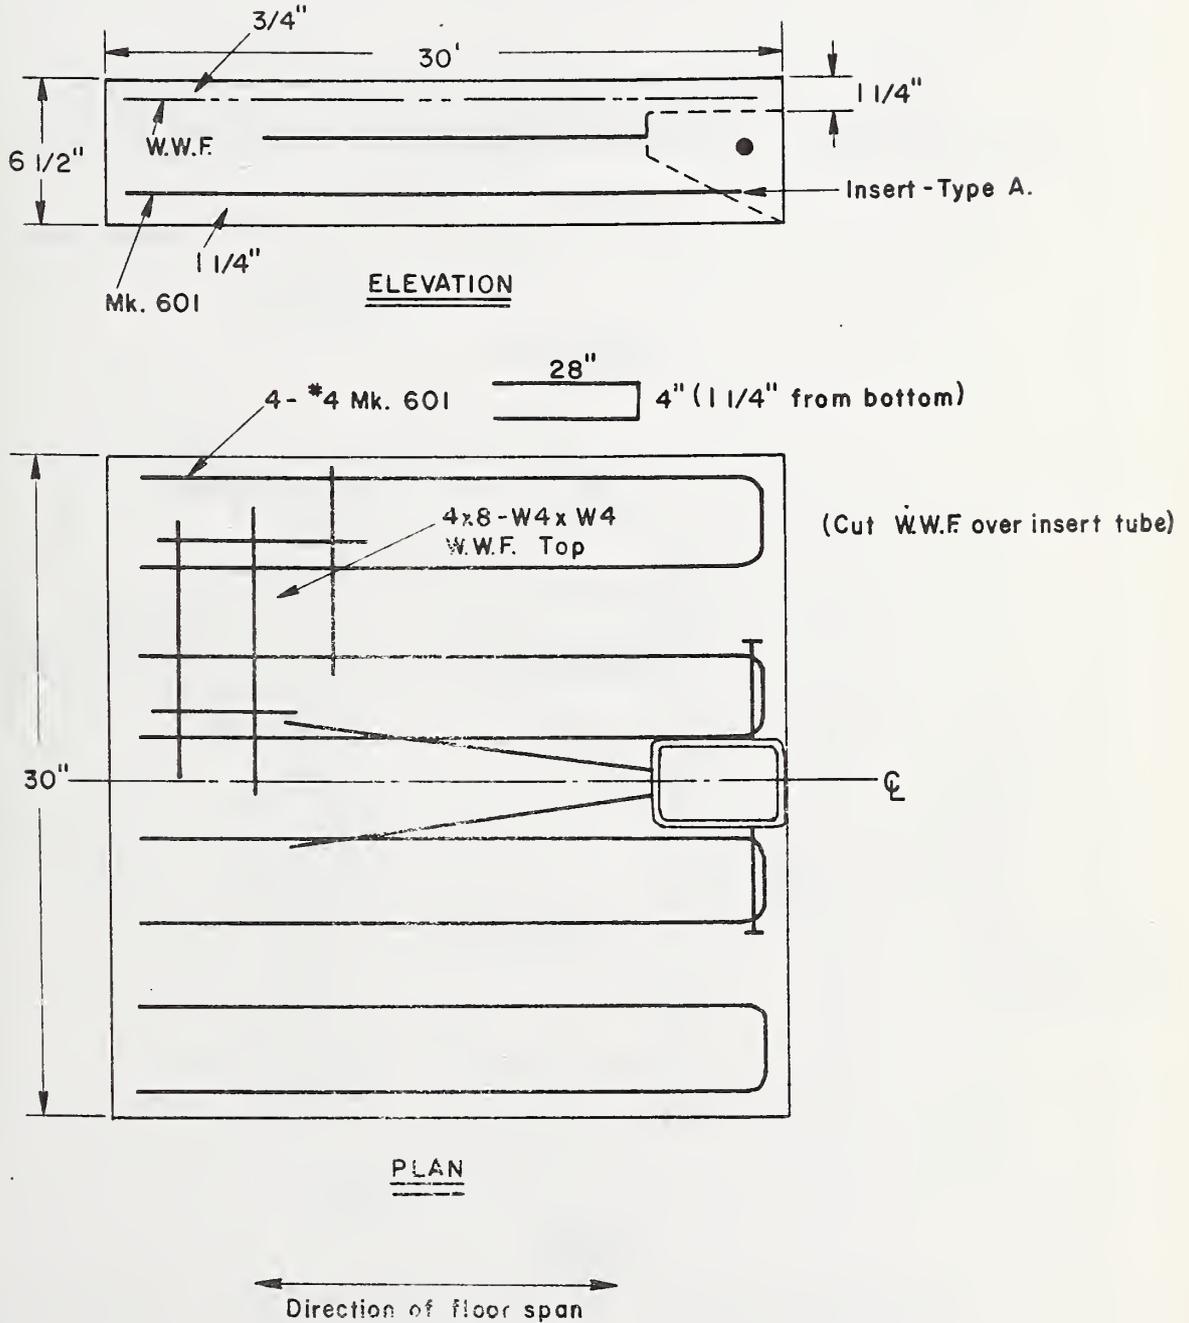
Concrete: 5000 psi @ 28 days
 Re. Steel: A-615 - Grade 60

Figure 2.2.4 Revised design of floor test specimens (Type A).

the design shown in figures 2.2.4 and 2.2.5 used a modified reinforcing detail to better simulate the restraint of prestressing. Specimens of the design shown in figure 2.2.6 were added to the test series to simulate a special condition requiring test evaluation; in these the insert (Type B) is situated close to a corner of a floor slab, 8 in from the side of a utility cut-out (see insert in figure 1.2.1 connected to labeled example of a typical Type B). The reinforcement in the specimens shown in figures 2.2.4 through 2.2.6 was considered reasonably representative of prototype construction.

In Test 1 (fig. 4.1.1) the element was embedded in a floor slab specimen using the revised design (fig. 2.2.4) which gave less restraint and was thought to be a more accurate simulation of actual conditions than the original specimen design. Typical resistance curves are shown in figures 4.1.2 and 4.1.3 which illustrate the load-displacement relationship for Test 1. In Test 2 the original specimen design (fig. 2.2.1) was used.

The hairpin bars in the Test 2 specimen, shown in figure 2.2.1, provided more restraint to the wing studs than the reinforcing bars used in the Test 1 specimen, shown in figure 2.2.4. The failure mode of these specimens (figs. 4.1.1 and 4.1.4) illustrates the important role of the wing studs and the potential effect of their confinement, since in both cases the concrete covering the wing studs failed. In figure 4.1.4 the specimen was "pulled away" after rupture of the tail anchors to better examine their condition. It can be seen in figure 1.2.2 that the concrete cover of these studs was only 1 1/2 in. Another factor that may have affected capacity was the grouting of the connector tube. However, although the Test 2 specimen was grouted, it is questionable whether this grout did increase its capacity since no deformation had been observed

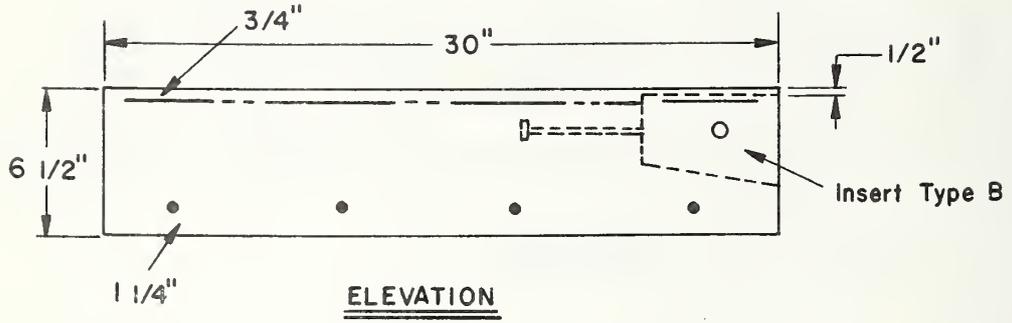
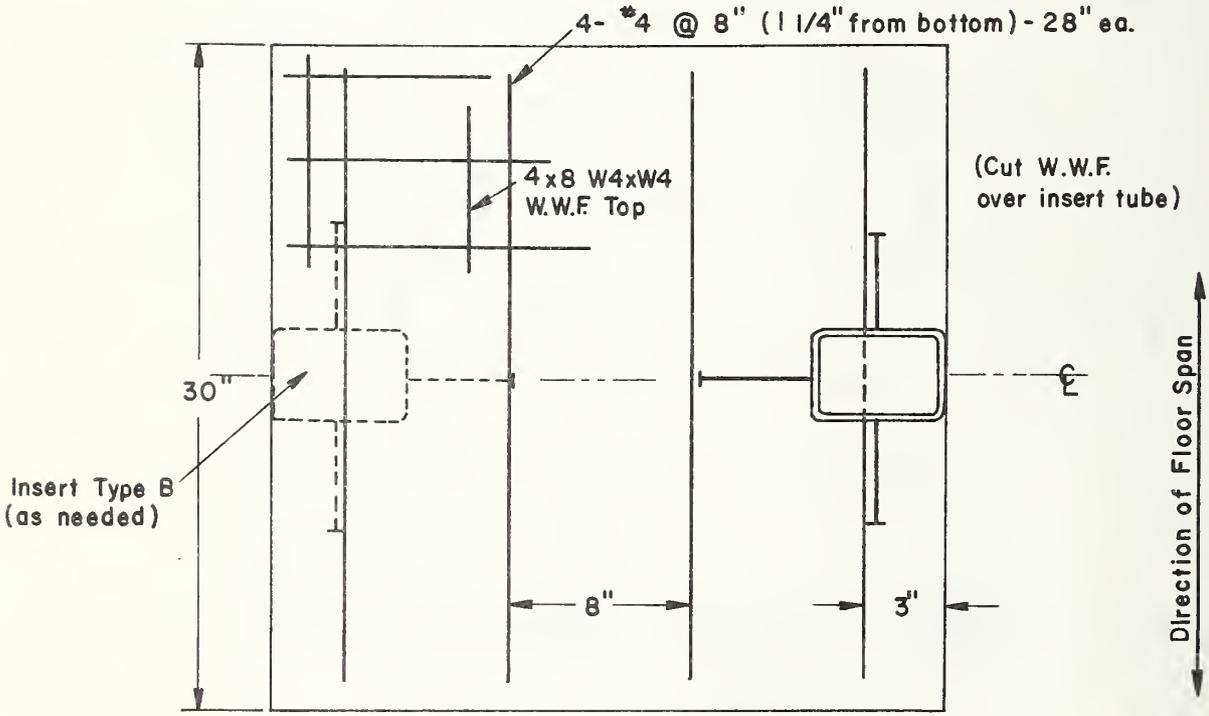
Concrete: 5000 psi @ 28 days
 Re. Steel: A-615-Grade 60

Figure 2.2.5 Revised design of floor test specimens (Type B).

Two specimens were tested (Tests 5 and 6). The Test 5 specimen (fig. 4.1.8) used the revised reinforcement detail (figure 2.2.5) and in the Test 6 specimen the original design (fig. 2.2.1) was used. While the Test 5 specimen was ungrouted, grout was used in the tubes and the joints of the Test 6 specimen. Another difference was in the test set-up. Test 5 used restrained support conditions, (fig. 4.1.8). In Test 6 the outer slabs were unrestrained (as shown in fig. 4.1.10) and could rotate. In the actual structures, individual floor slabs are only partially restrained from rotation and grouting of the joint might not be used. Test 5 is considered the simulation which provides an indication of the connection element strength with less risk.

The Test 7 specimen (fig. 4.1.11) contained the revised reinforcement design (fig. 2.2.5) and no grout. The Test 9 specimen contained the revised reinforcement design and grout in the connector tubes but not in the joints. Tests 10 and 11 used specimens similar to those in Tests 7 and 9, respectively, except that the connector was located close to the corner of the slab simulating a critical design condition. Test 8 used the original design (fig. 2.2.1) and grouting of the tubes as well as the joints. Test 10 is considered the simulation which would be expected to provide the least strength. However, the variables in Tests 7, 9, 10 and 11 apparently did not affect load resistance.

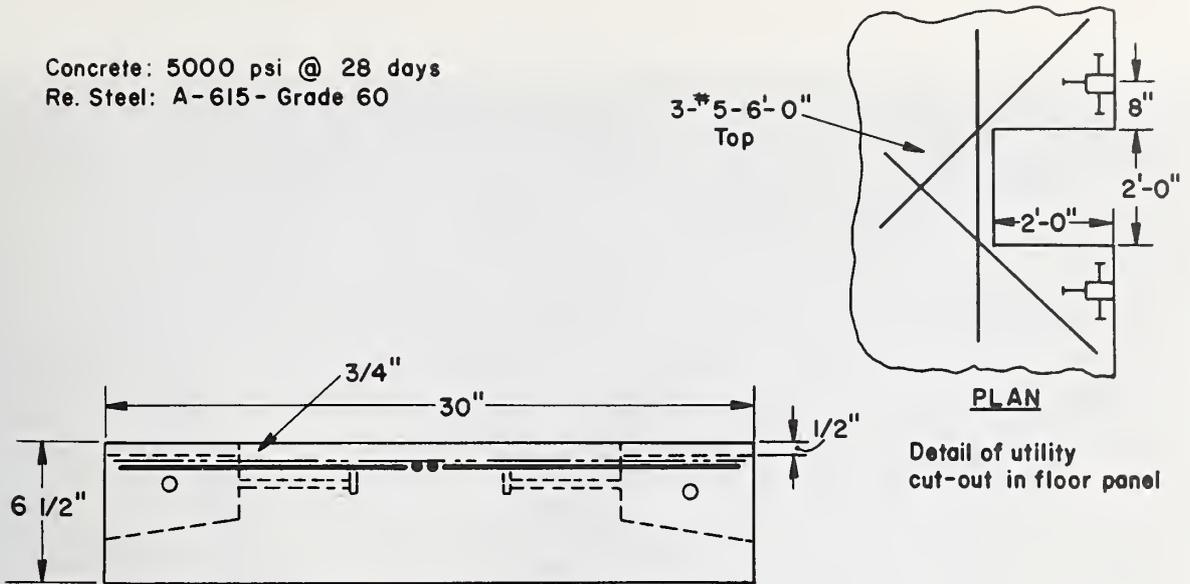
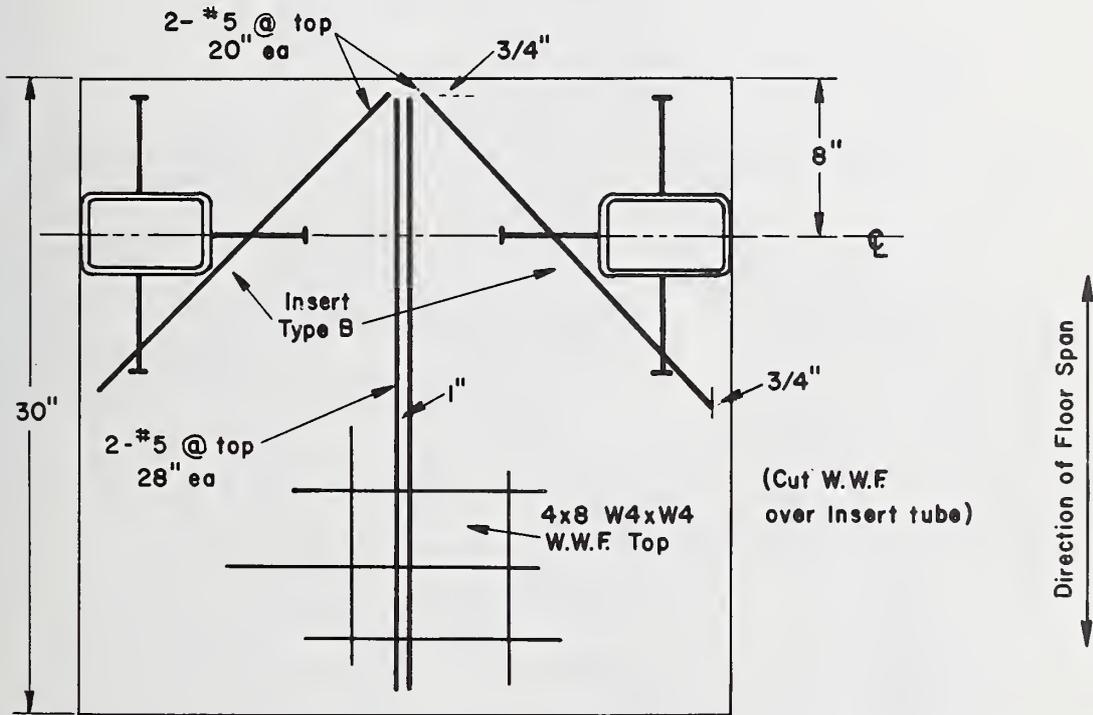
Concrete: 5000 psi @ 28 days
 Re. Steel: A-615 - Grade 60

Figure 2.2.6 Revised design of floor test specimens near corner (Type B).

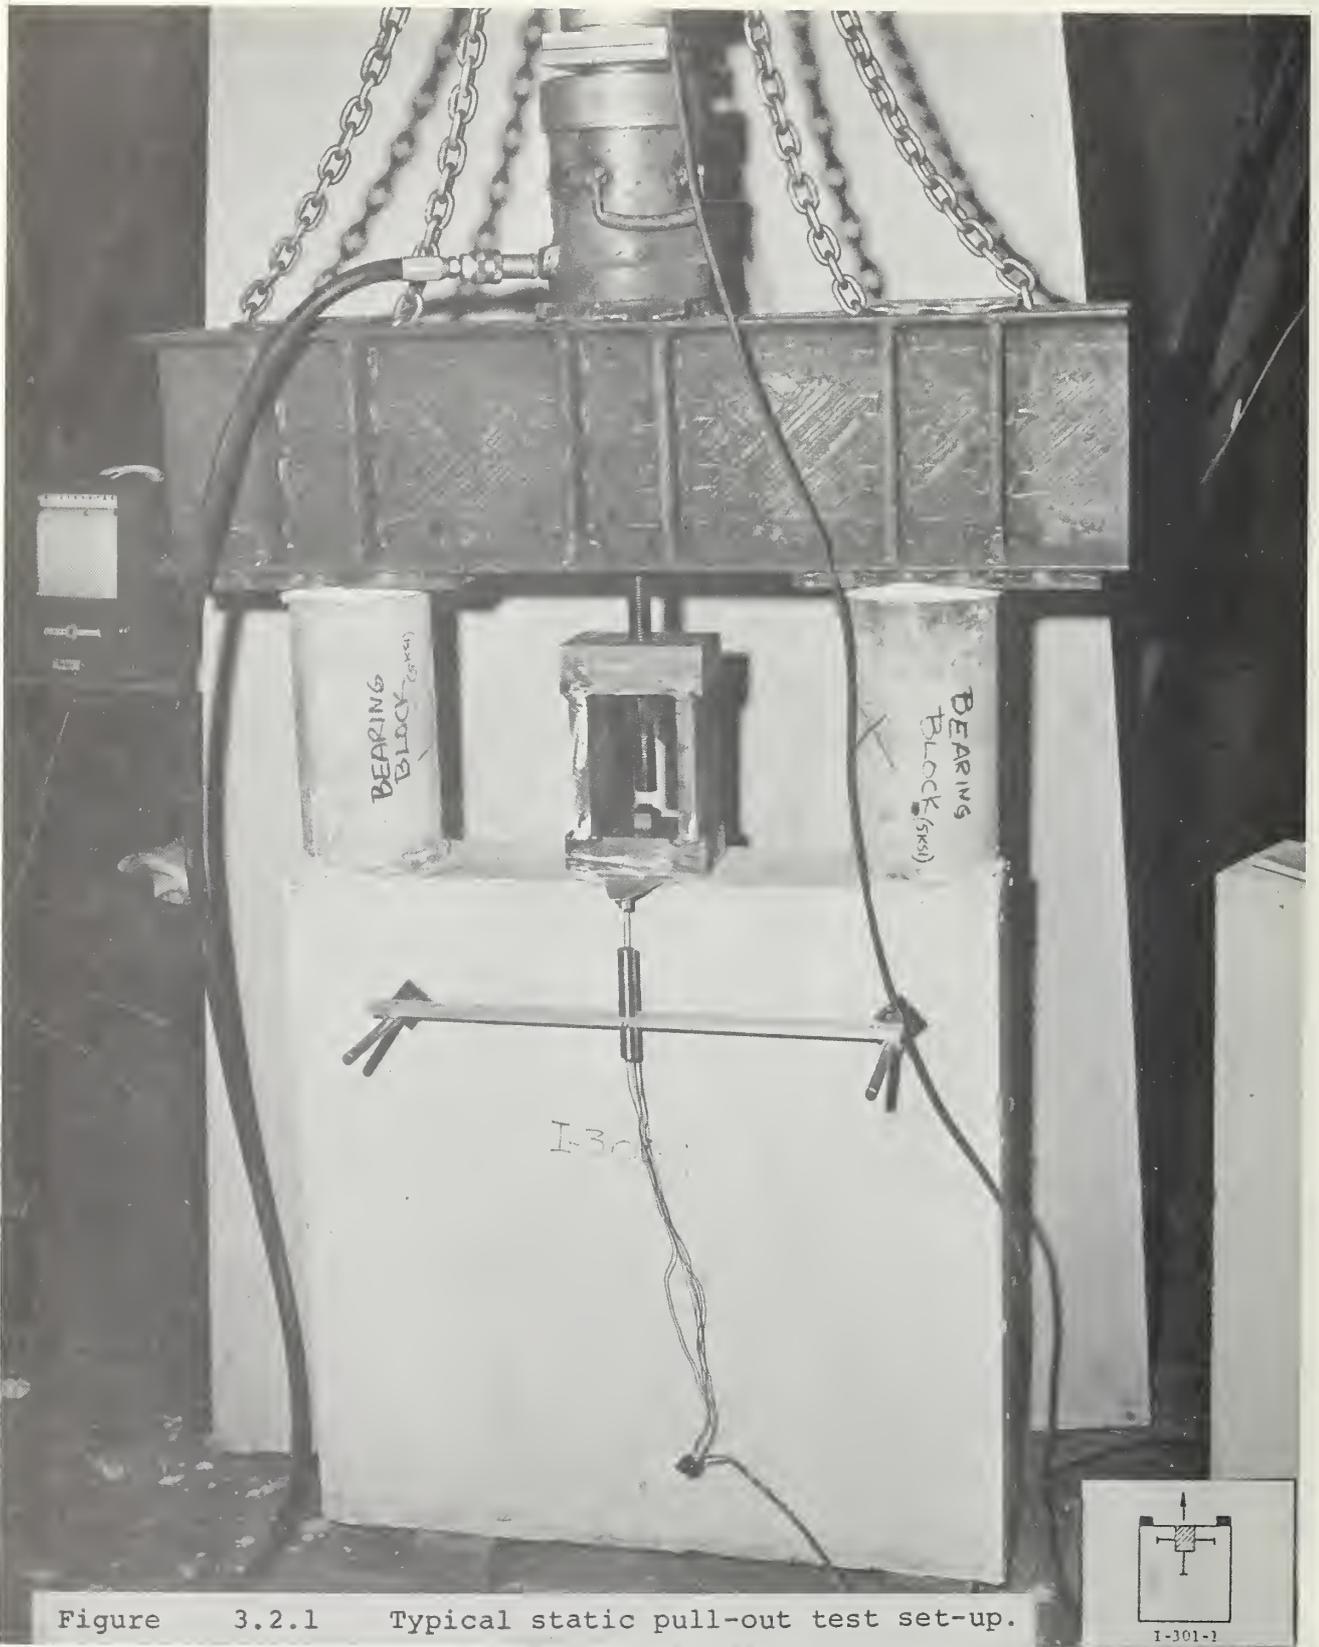
Figure 3.2.1 Typical static pull-out test set-up.

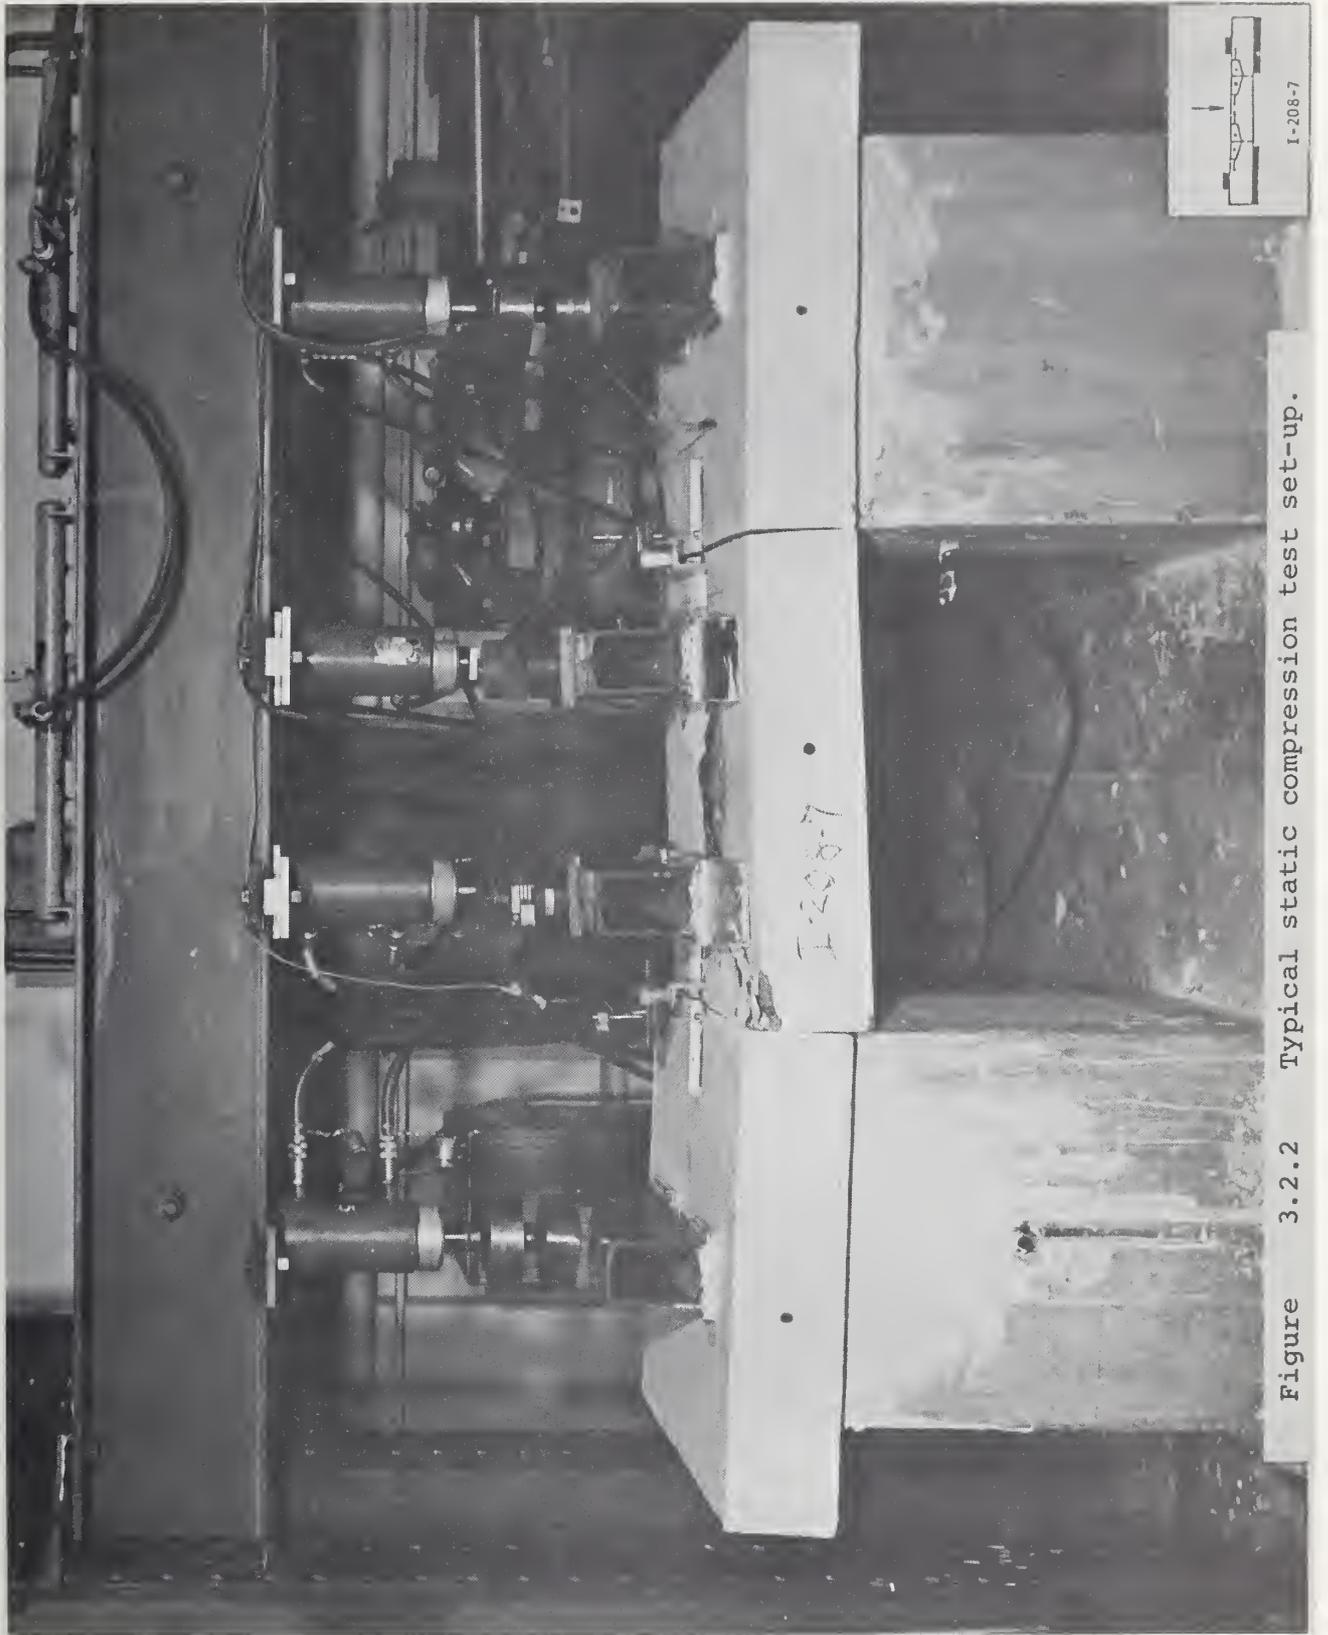
Figure 3.2.2 Typical static compression test set-up.

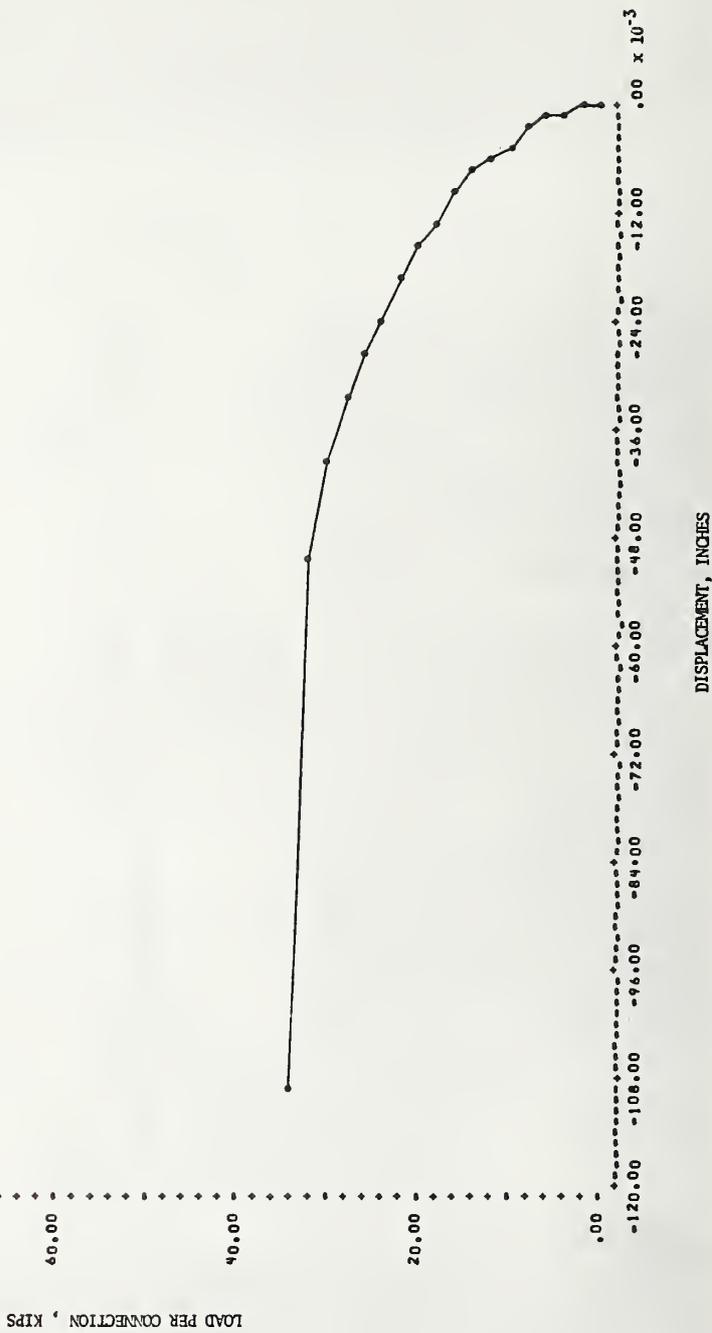
PLOT OF INSTRUMENT 3 LOAD IN KIPS 100 KIP CELL
VS. INSTRUMENT 5 LVDT FRONT .001 IN

Figure 4.1.2 Load-displacement graph for front of Test 1.

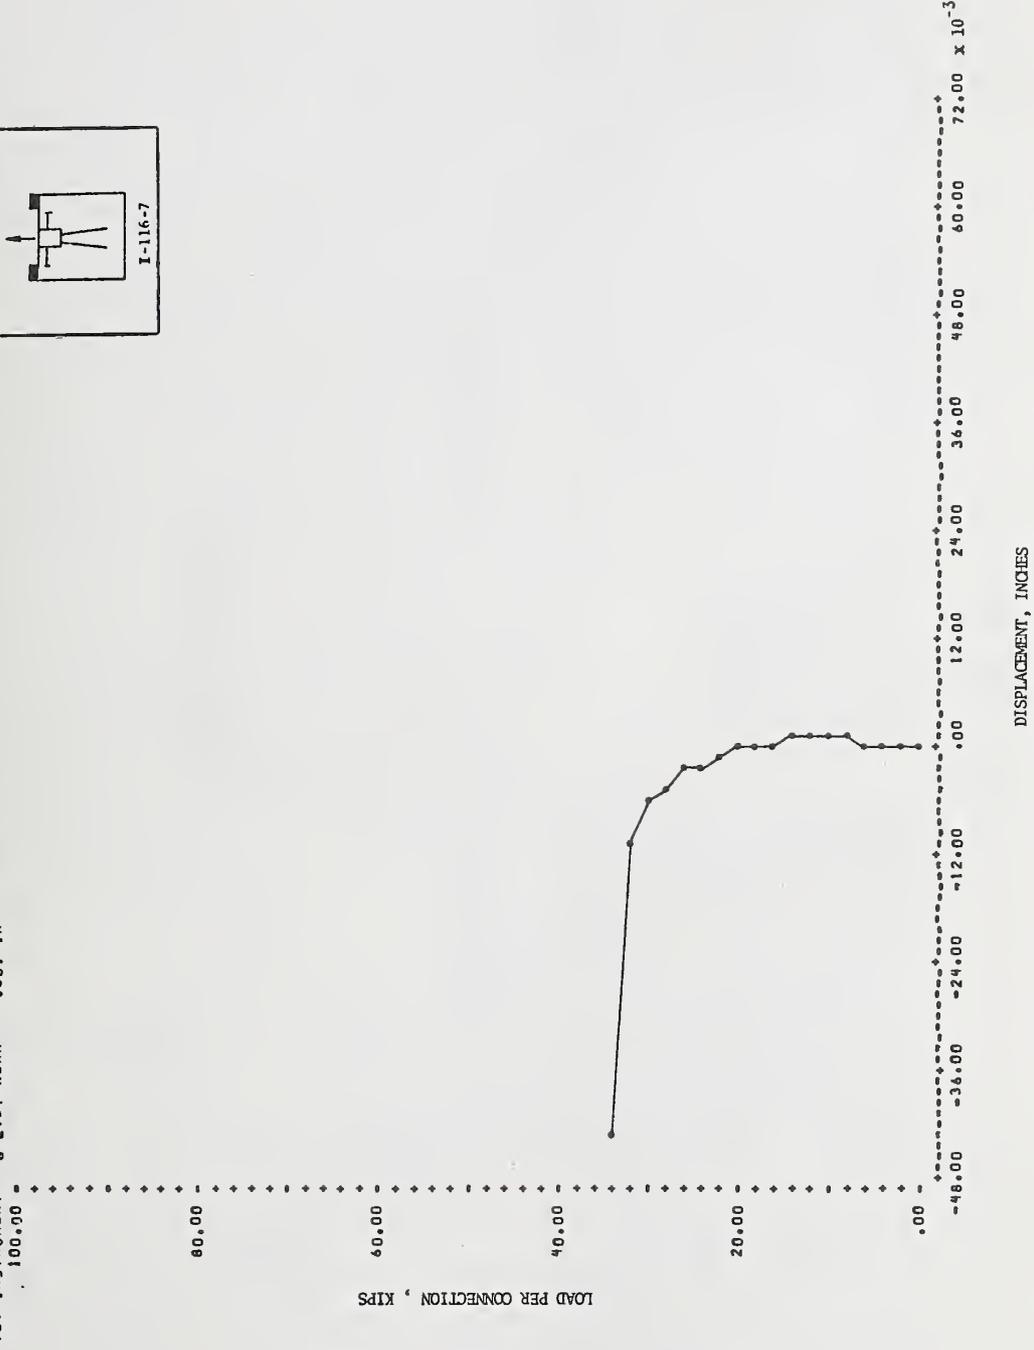
PLOT OF INSTRUMENT 3 LOAD IN KIPS 100 KIP CELL
VS. INSTRUMENT 6 LVDT REAR .001 IN

Figure 4.1.3 Load-displacement graph for rear of Test 1.

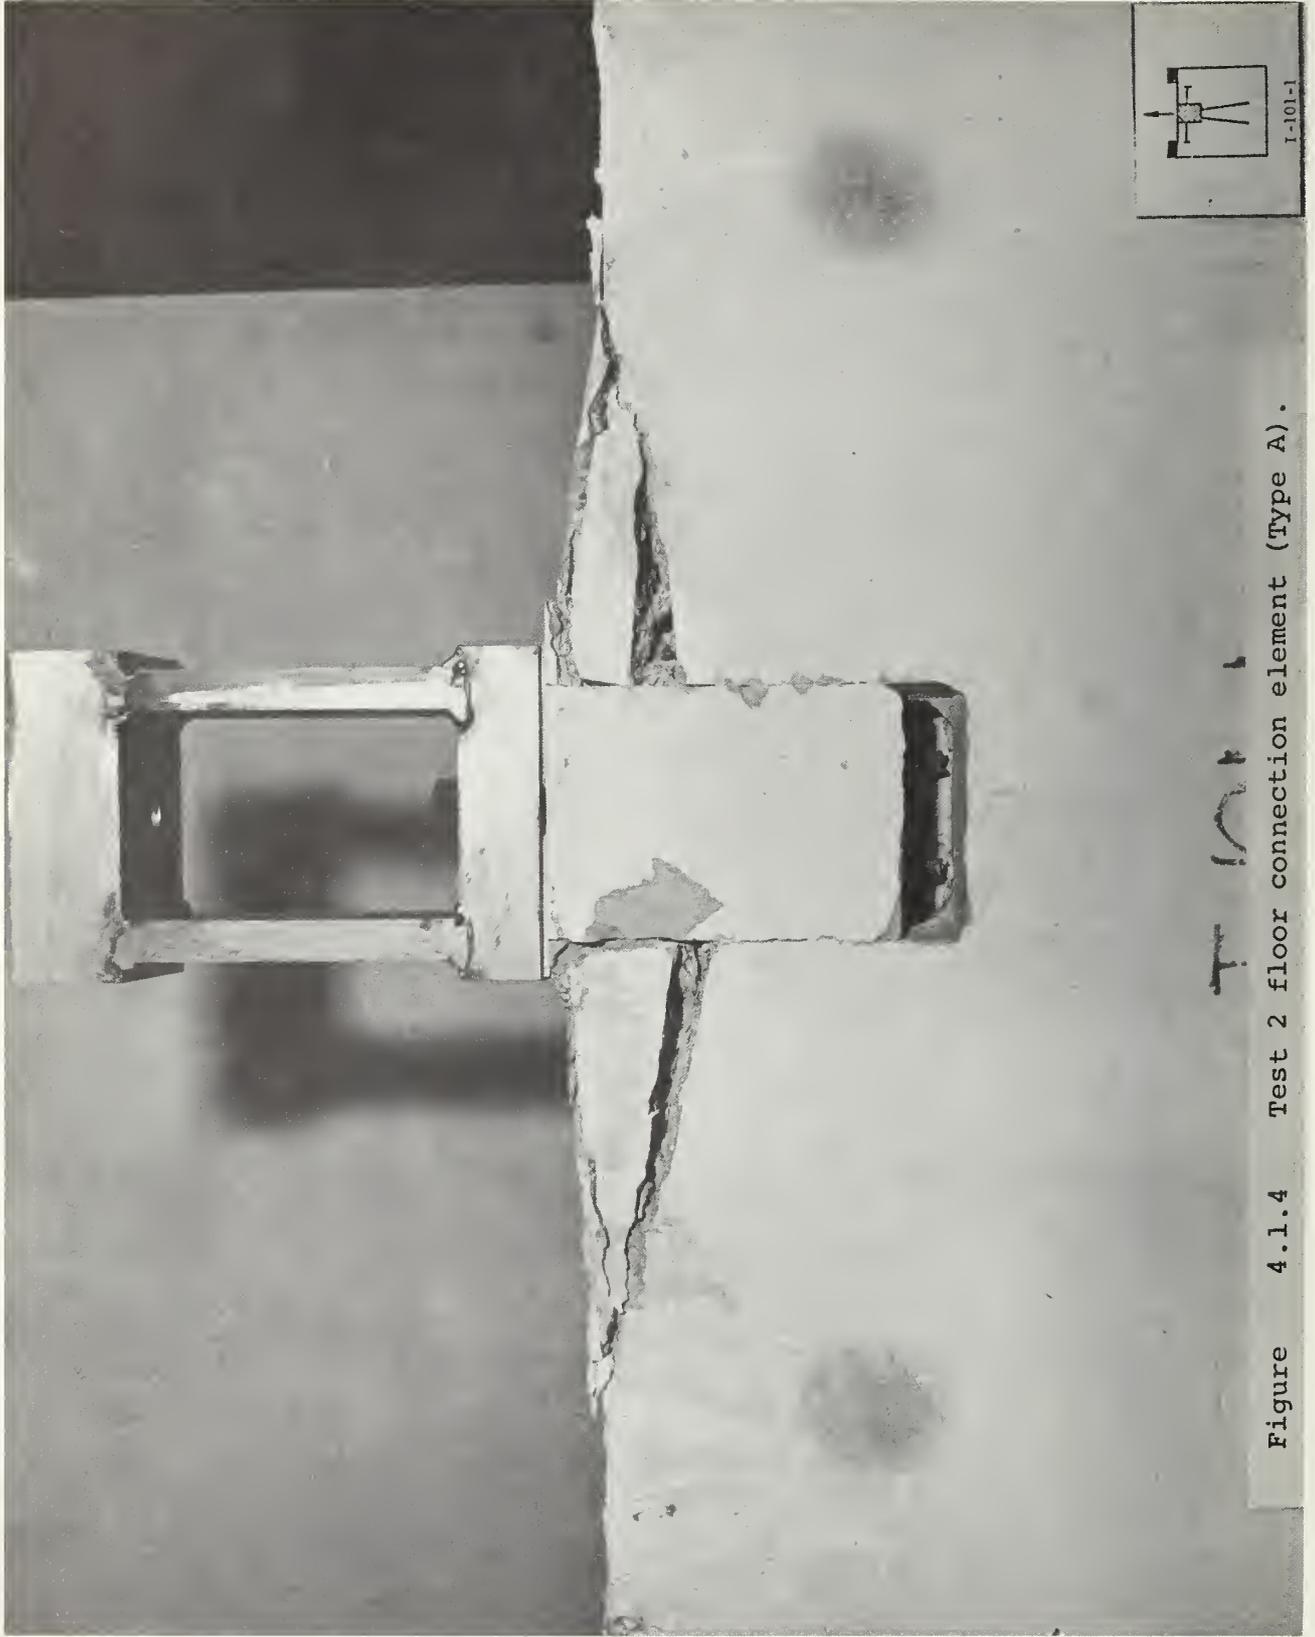
Figure 4.1.4 Test 2 floor connection element (Type A).

I-101-1	Floor to Wall	4.1.4	(Orig.) 2.2.1	>5000 ^e	(In insert) 5510	A	3/4	1420	Tension	38.7	0.045	Loaded to 48kip max. at deformation >0.28 in; no cracking observed in grout fill; tensile failure of both tail anchor bars.
3

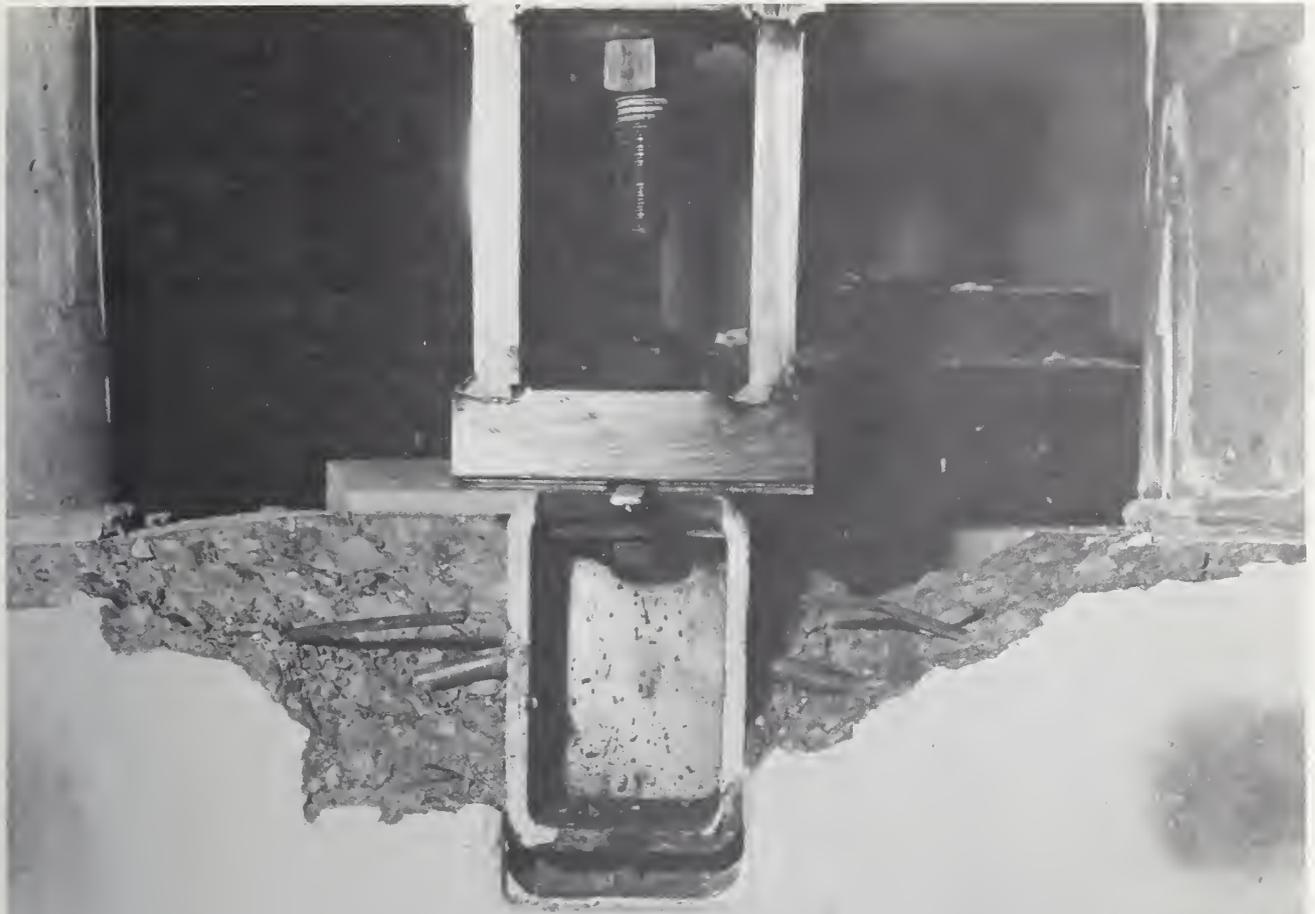
Figure 4.1.5 and 4.1.7 illustrate the failure mode. There was a tensile failure in the tail stud as is illustrated by the typical load-displacement curve shown in figure 4.1.6. The wing studs were bent but did not rupture.

Figure 4.1.5 Front of Test 3 floor connection element (Type B).

I-316-7	Floor to Floor	4.1.5 4.1.6 ^g	(Revis.) 2.2.5	6400	w/o	B	3/4	28400	Tension	18.0*	0.040	Loaded to 22kip max. at deformation >0.31 in; no instability of insert tube observed; tensile failure of tail stud.

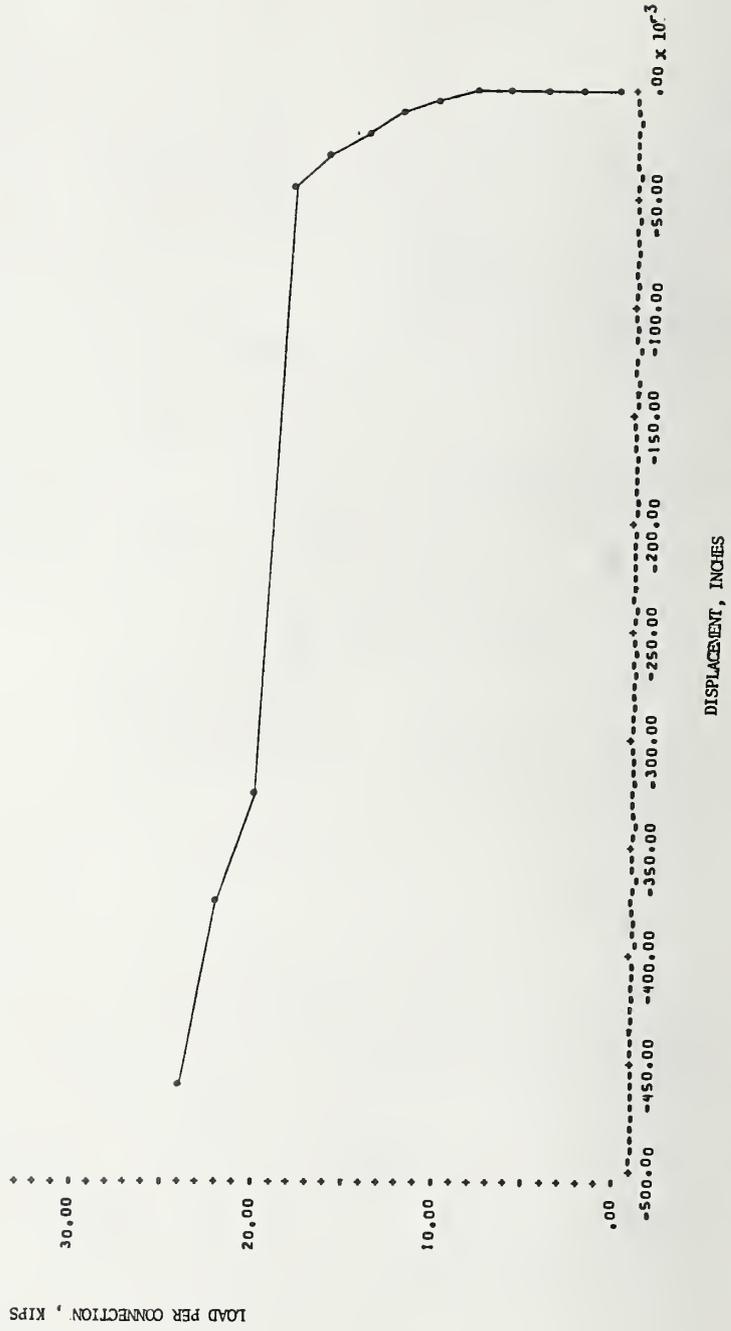
Figure 4.1.6 Load-displacement graph for front of Test 3.

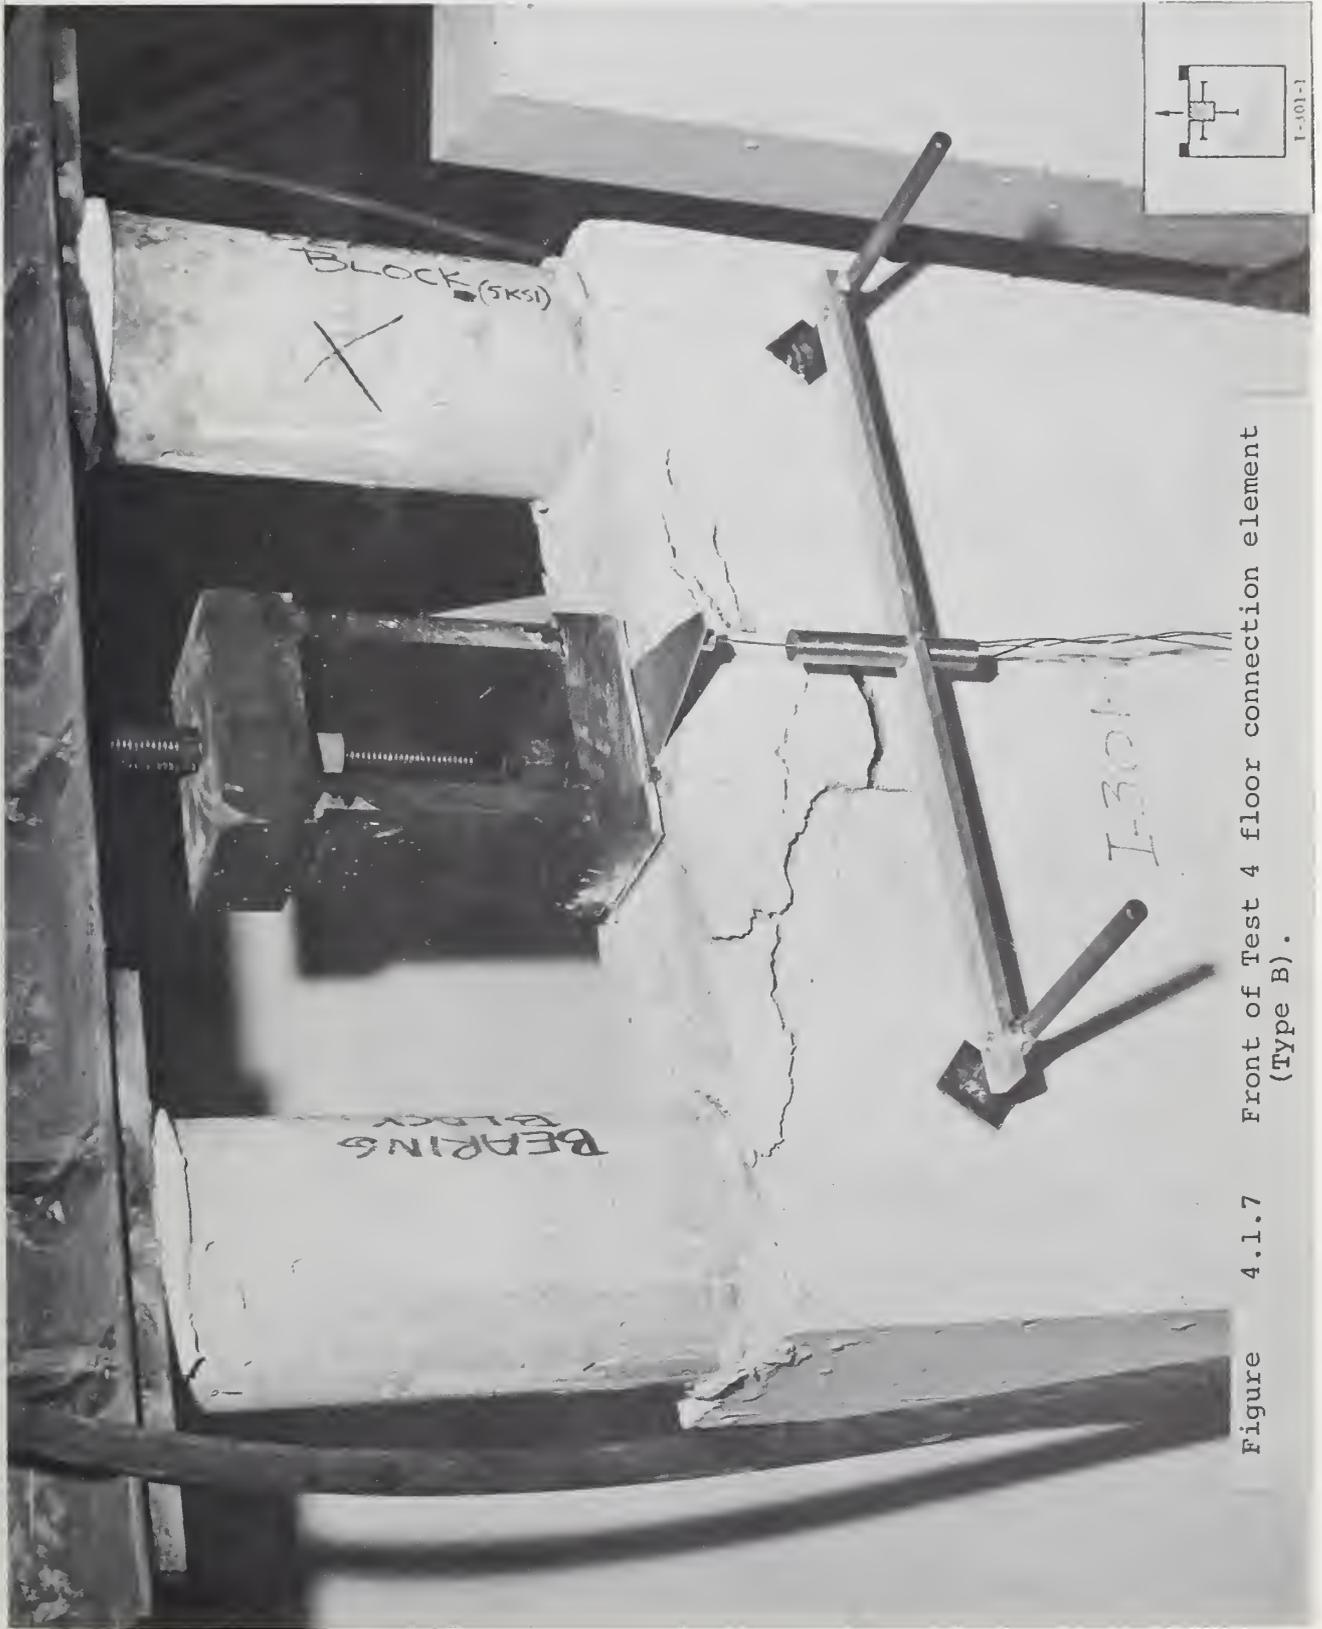
Figure 4.1.7 Front of Test 4 floor connection element (Type B).

I-301-1	Floor to Floor	3.2.1 4.1.7	(Orig.) 2.2.1	>5000 ^e	(In insert) 6140	B	3/4	28400	Tension	30.0	0.010	Loaded to 42kip max. at deformation >0.25 in; grout inside insert tube not cracked; tensile failure of tail stud.
5
